Waste 4 Fuel

Visual Waste Characterisation Assessment

Environment Agency

14 February 2014

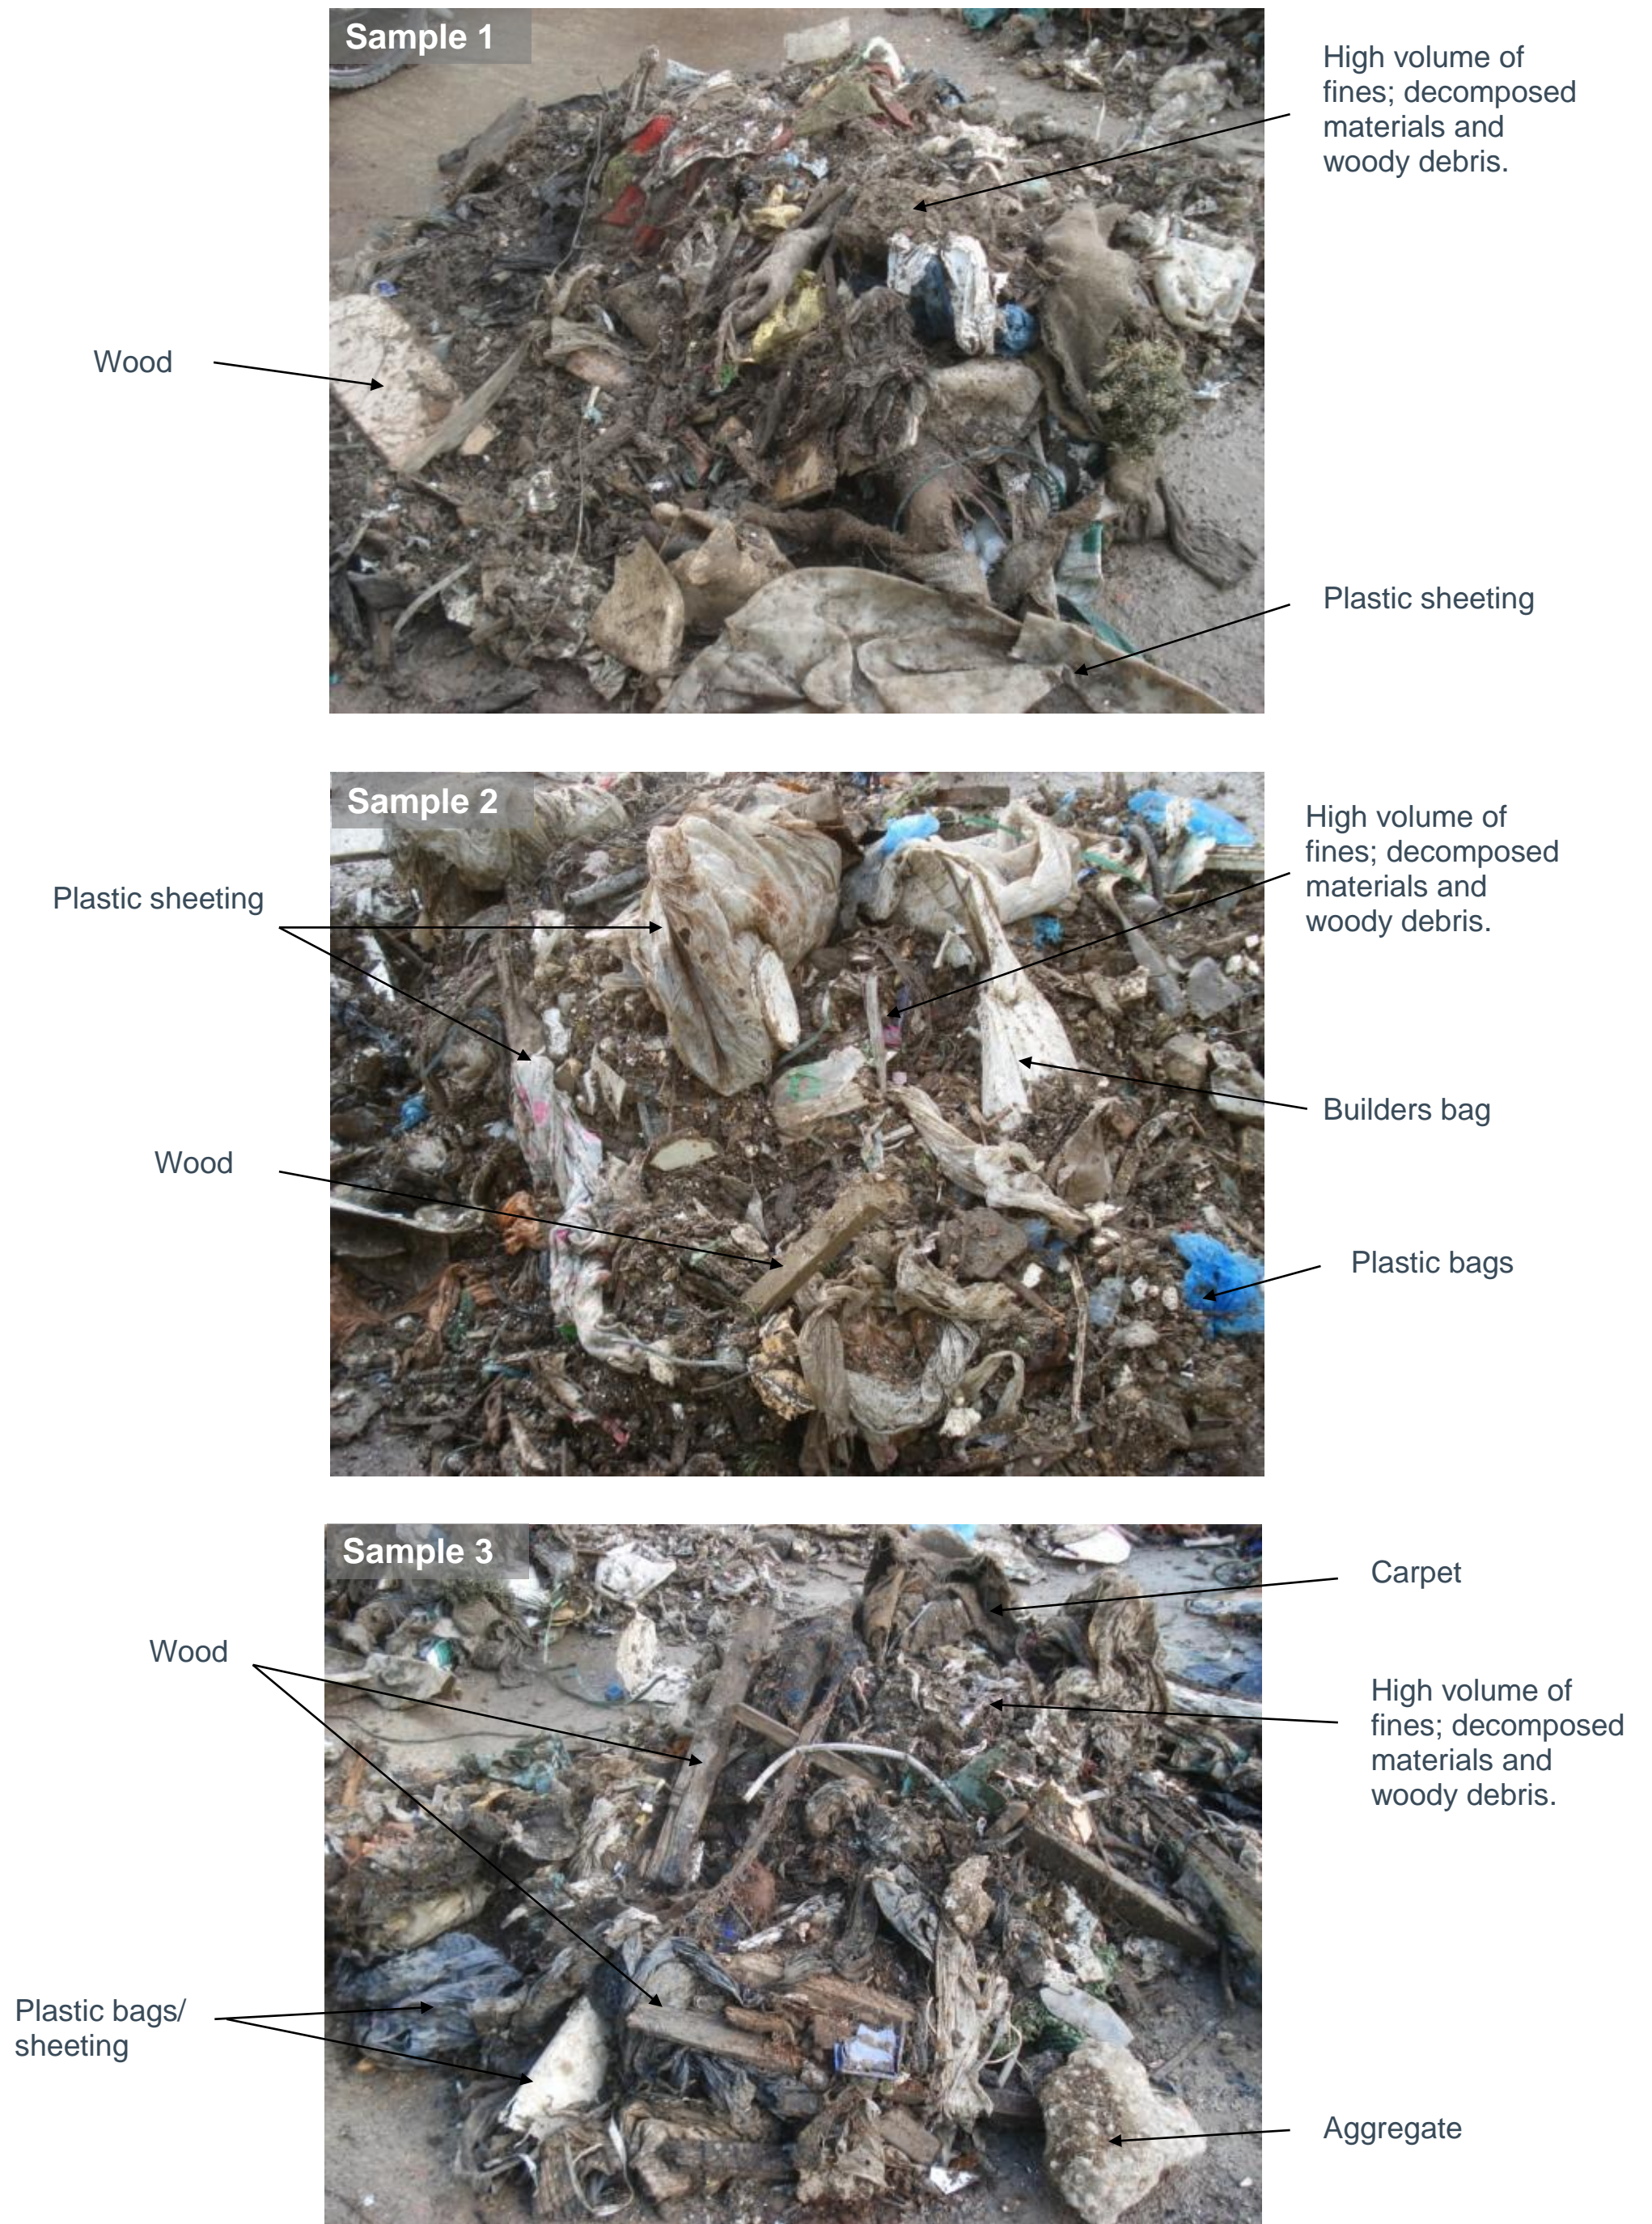
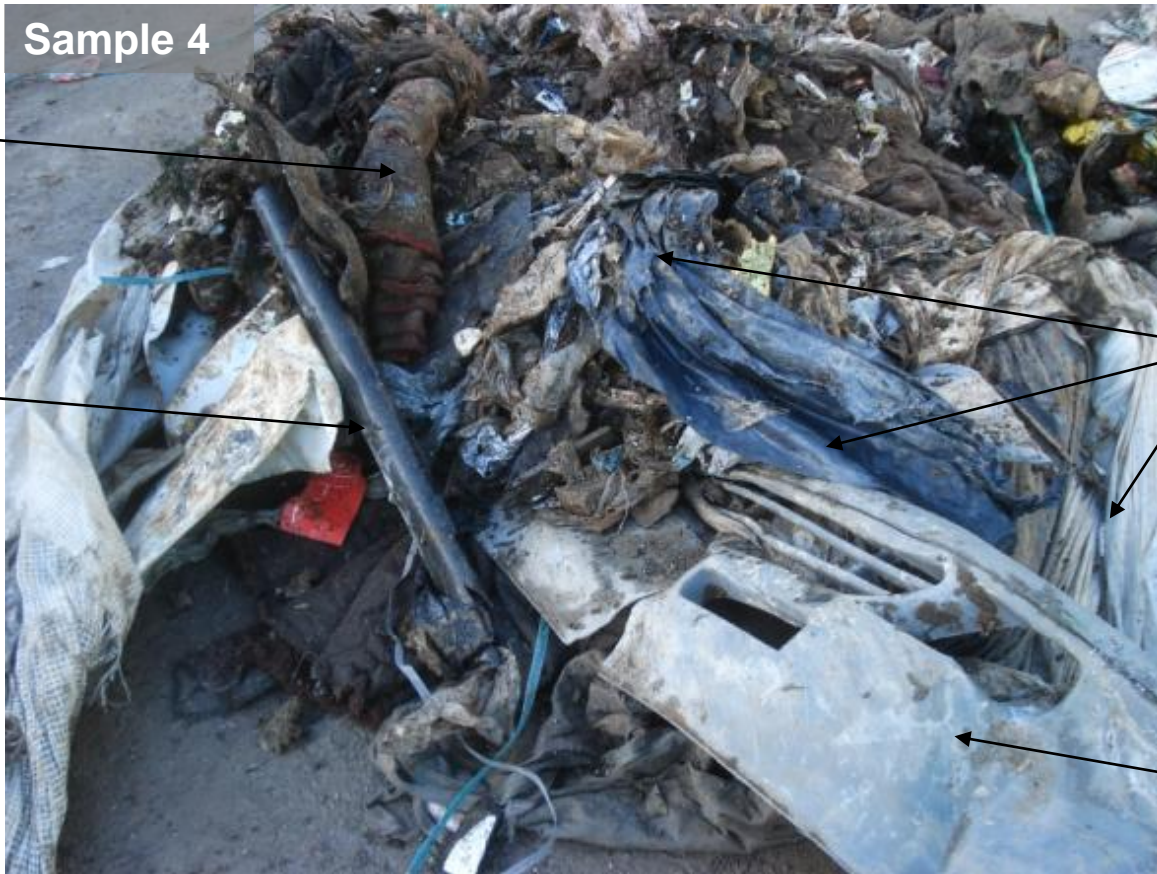
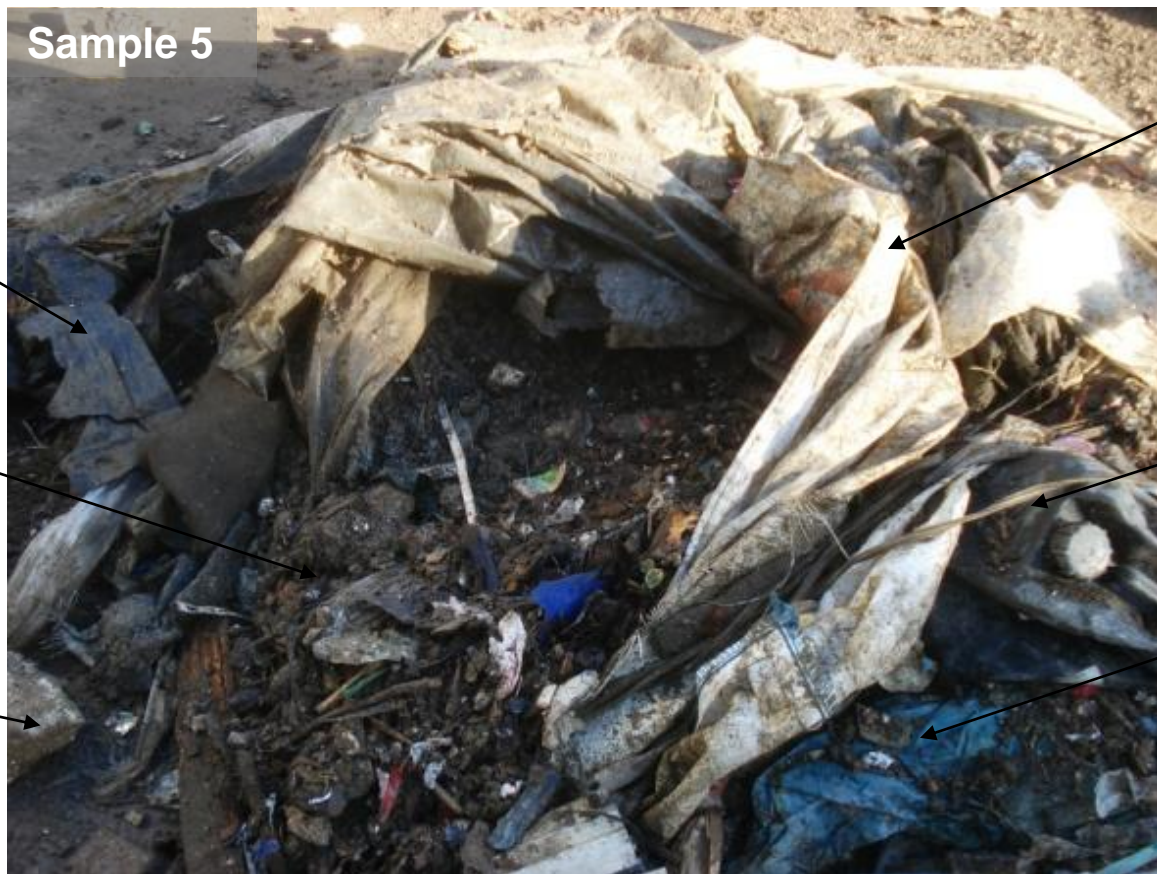
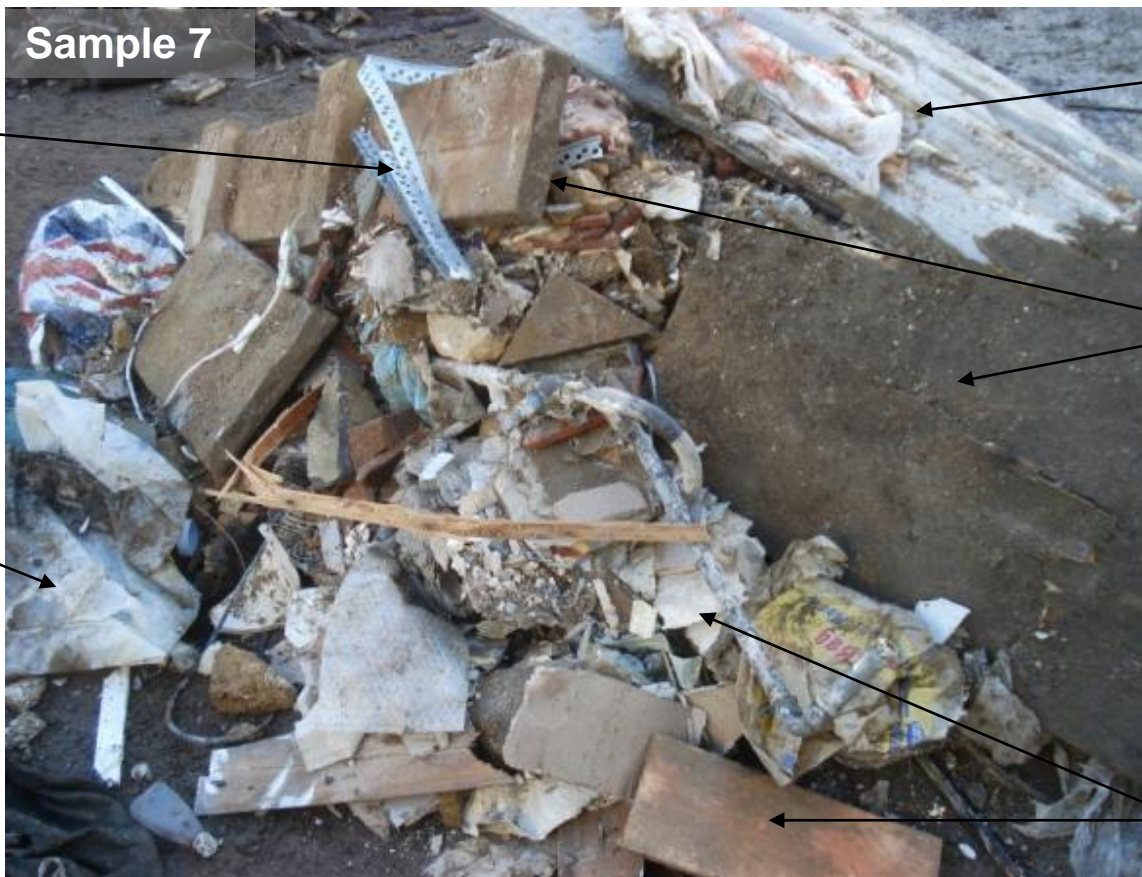
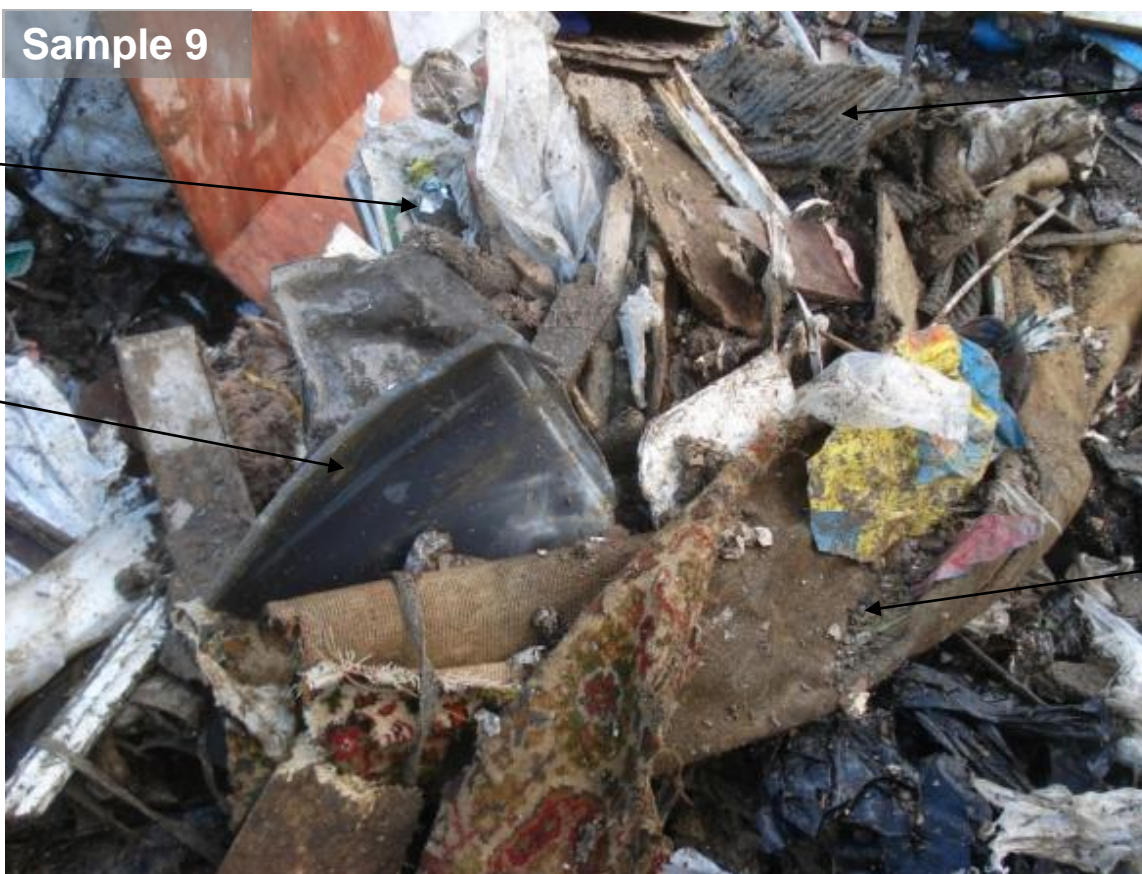
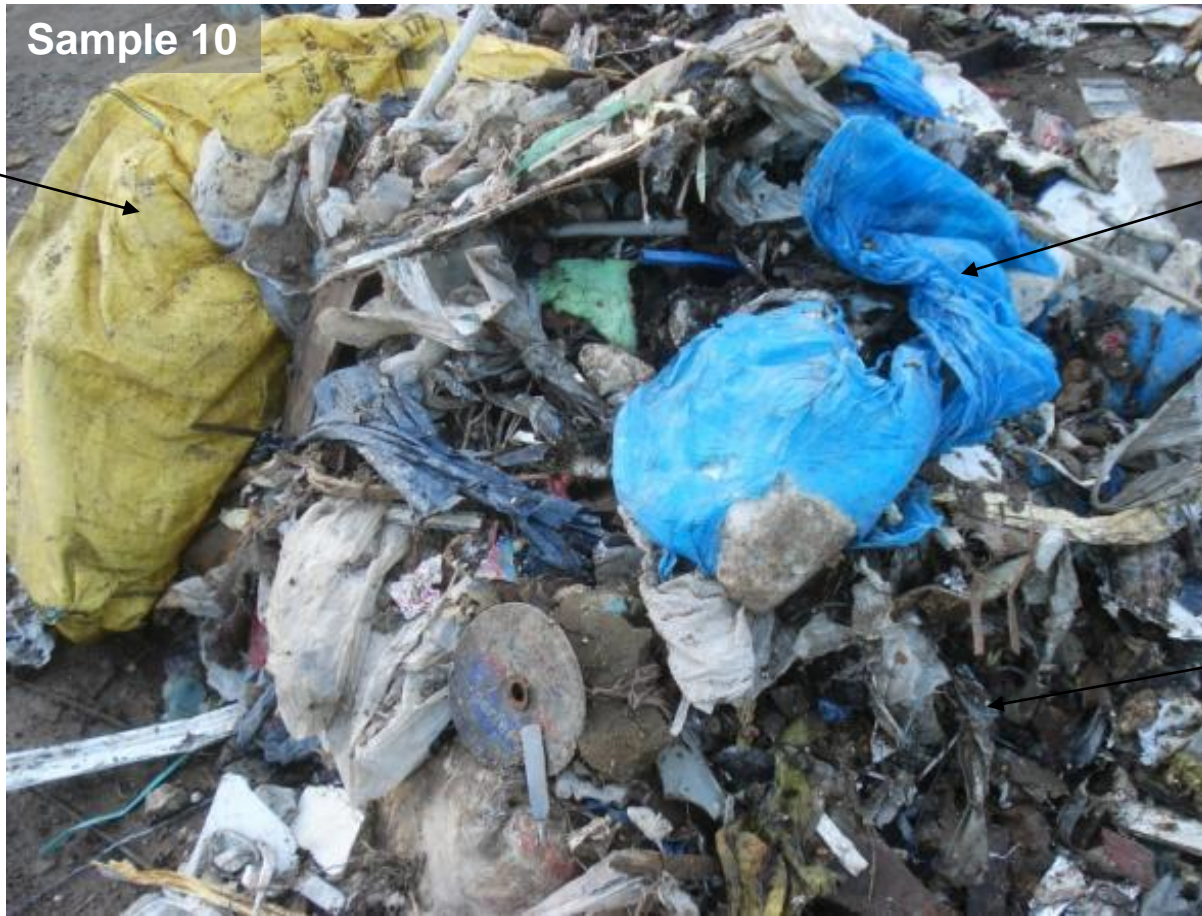
Figure 3. Sample Observations

It was clear from the samples that the waste materials identified were consistent with the information provided to Atkins by Waste 4 Fuel. Namely that the majority of waste appeared to originate from house clearances or building activities. Several of the samples contained 'builders bags' large bulk waste bags for containing assorted, but principally building related wastes. None of the samples assessed were seen to contain organic household food related waste. The highest recorded wastes in the overall average across the samples included 24% of plastics, with frequent plastic sheeting, 14% wood and 16% textiles which included carpets and/ or underlay in almost every sample, a mattress and tent on one occasion, and shed felt on two occasions. Other occasional materials included aggregates such as brick, rubble, masonry or ceramic tiles at 6%, although one instance of 30% was recorded. Rare instances of metals were observed although these were likely to have been limited because of possible extraction by the pre-sort process before the waste was deposited to the stockpile. This was evident by the large quantity of metal which was seen accumulating in one of the pre-sort bunkers.

By far the most common material recorded in all the samples were 'fines'. This category was used to define much of the indistinguishable proportion of waste which comprised of what appeared to be small particles of decomposed waste, potentially comprising of wood and soil like matter, and which was present in many of the samples. It was difficult to assess this waste to determine its constituents. The overall average across the samples was almost 40% making this the largest proportion by volume of all the categories used, with a maximum of 60% recorded in one sample and 8% in the lowest. Many of the samples assessed appeared to be 'older waste' and in an advanced state of decomposition which would account for the higher volume of this material. It is considered likely that much of the stockpile could comprise of this type of material as waste has decomposed and broken up over time.

Builders bag

Plastic bags/
sheeting

High volume of
fines; decomposed
materials and
woody debris.

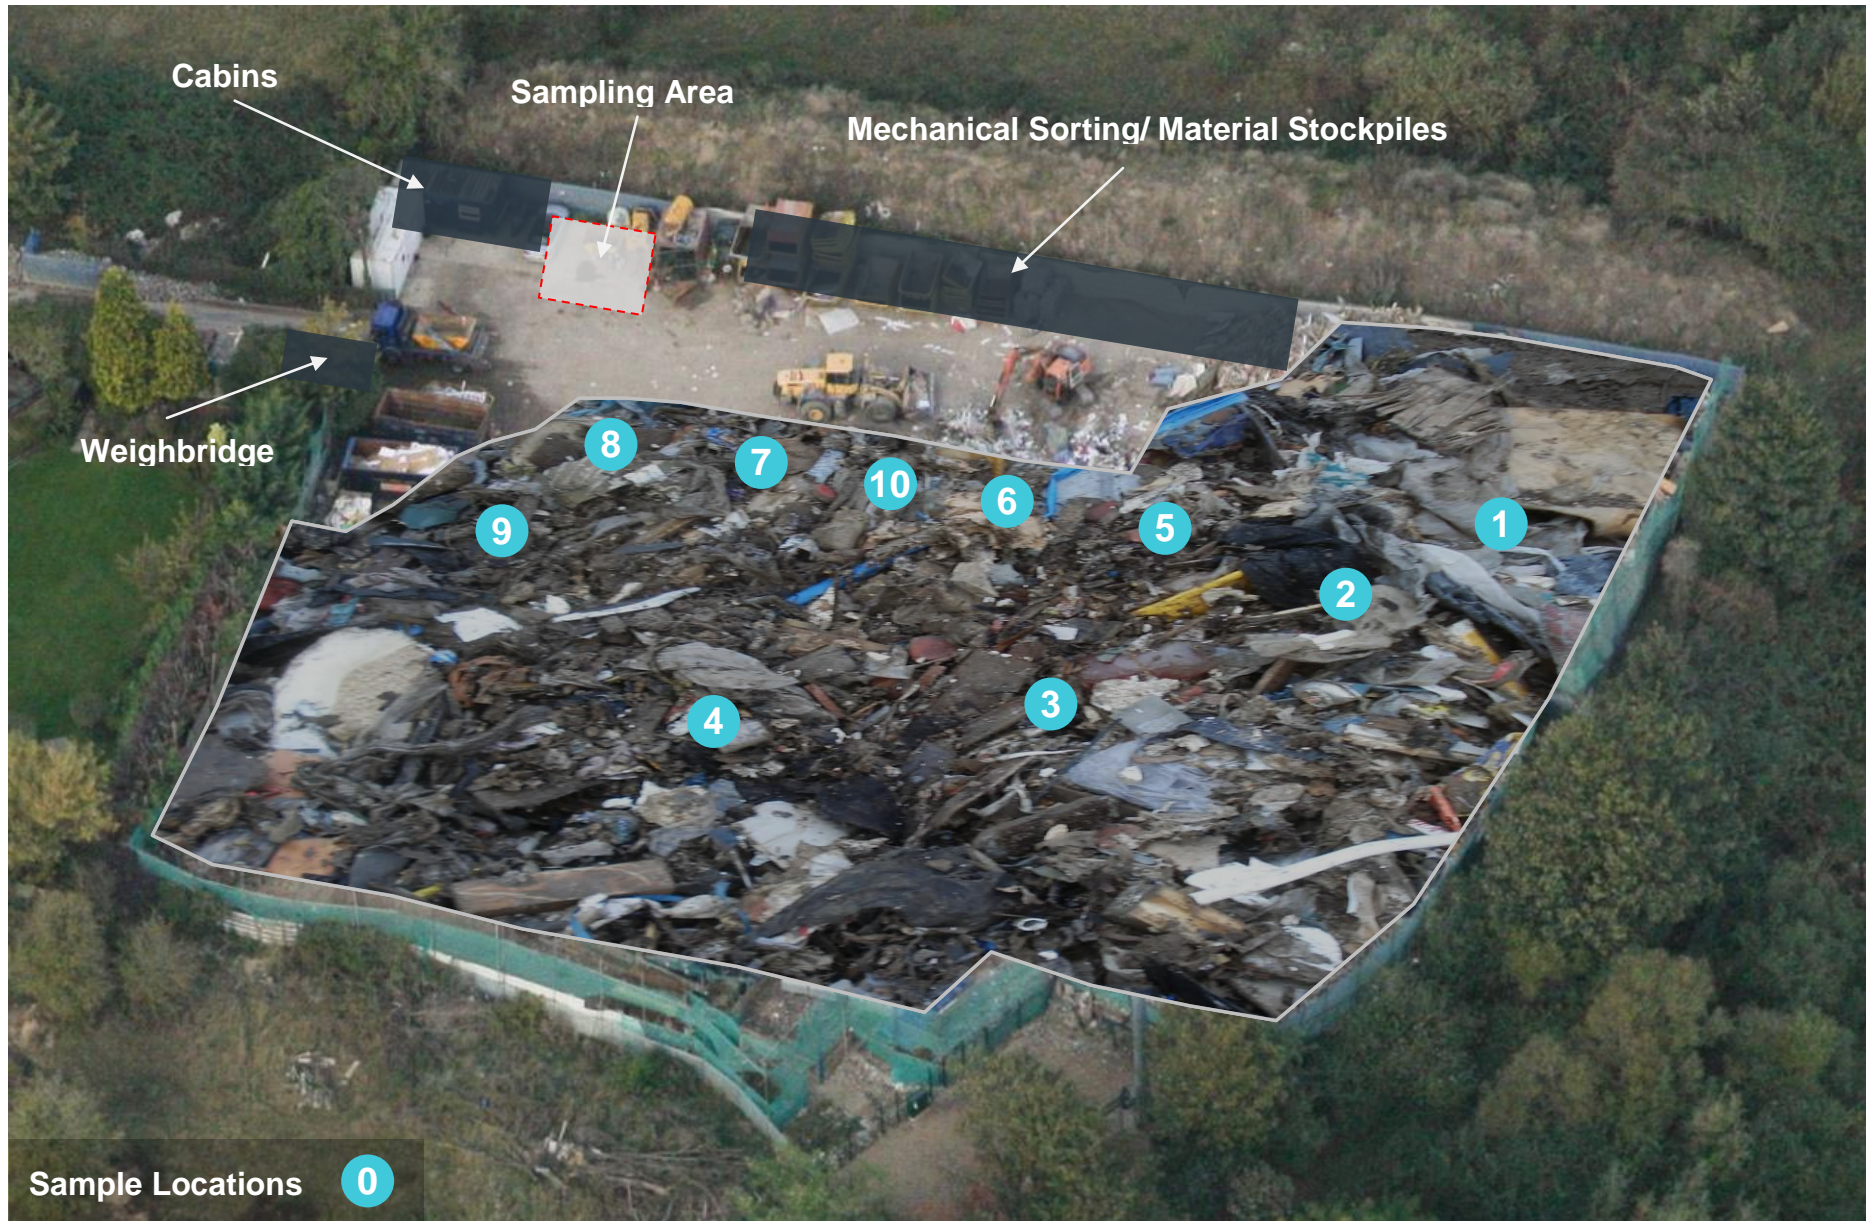
Appendix B. Site Plan

Due to access constraints it was not possible to sample waste buried deeper in the stockpile. As a result all samples were taken from the stockpile edge and top which were accessible by the site excavator. As each sample was taken the approximate location was recorded, these are identified on the sample plan included within Appendix B.

Waste 4 Fuel provided Atkins with access to their excavator and driver to assist with obtaining the samples. A sample storage area was defined within the site to conduct the sampling (see Appendix B).

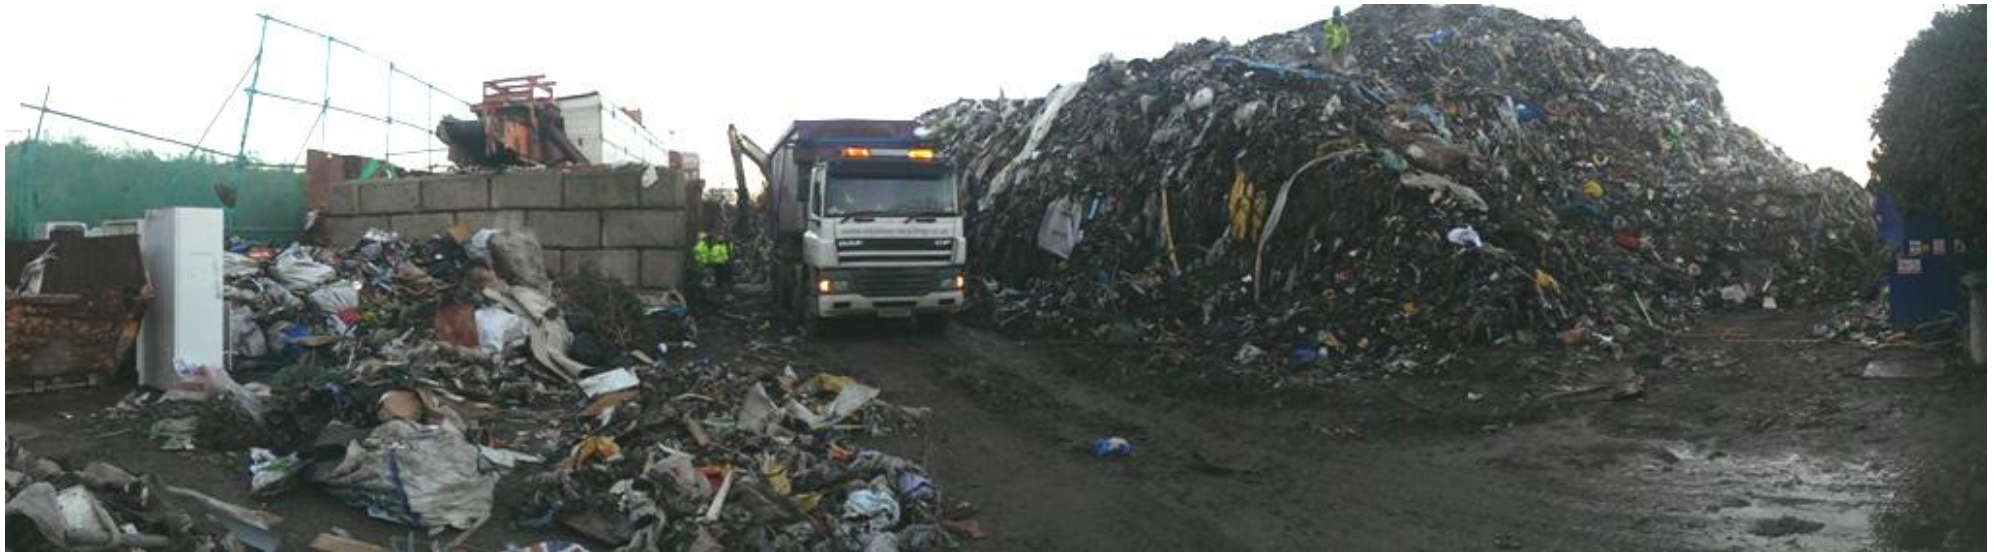
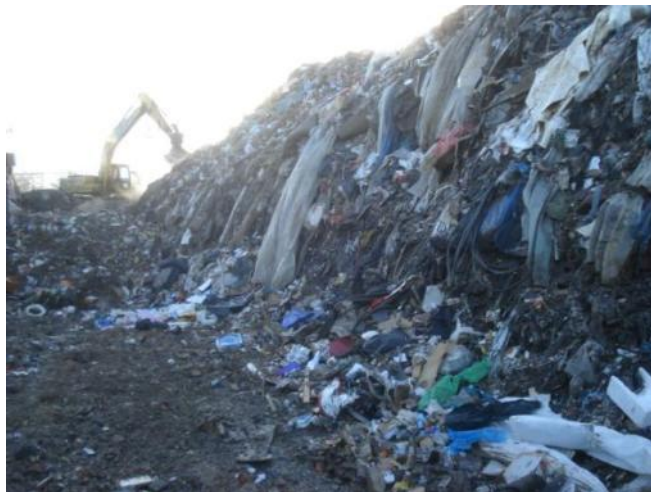
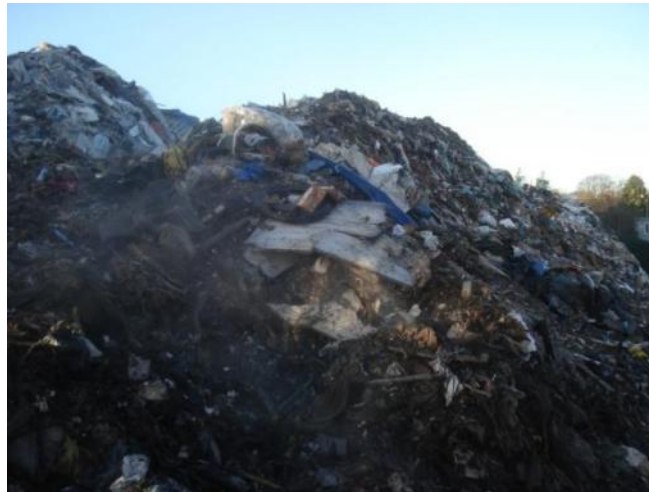
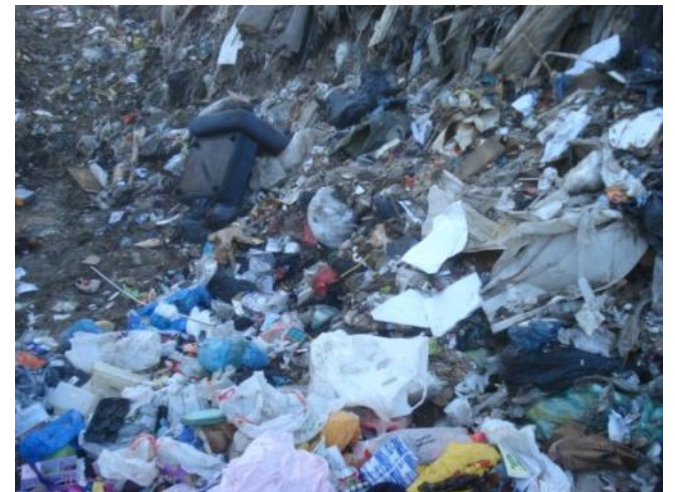
Stockpile

Looking to the greater stockpile it was observed that much of the material was consistent with what was sampled as can be seen in Appendix C. The surface was covered in loose plastic sheeting, and the stockpile appeared to contain a high volume of plastic and wood. Other materials noted include items of furniture such as sofas and mattresses.
